Re: August 2012 Monthly Progress Report
Administrative Settlement Agreement and Order on Consent for Removal Action
U.S. EPA Region 10 Docket No. CERCLA 10-2009-0255
Gasco Sediments Site within the Portland Harbor Superfund Site

Attachment A Monthly Visual Monitoring Report for Pilot Cap Vicinity

Visual Observations Log Form

Monitoring Period: Monthly (Year 6)—August 2012

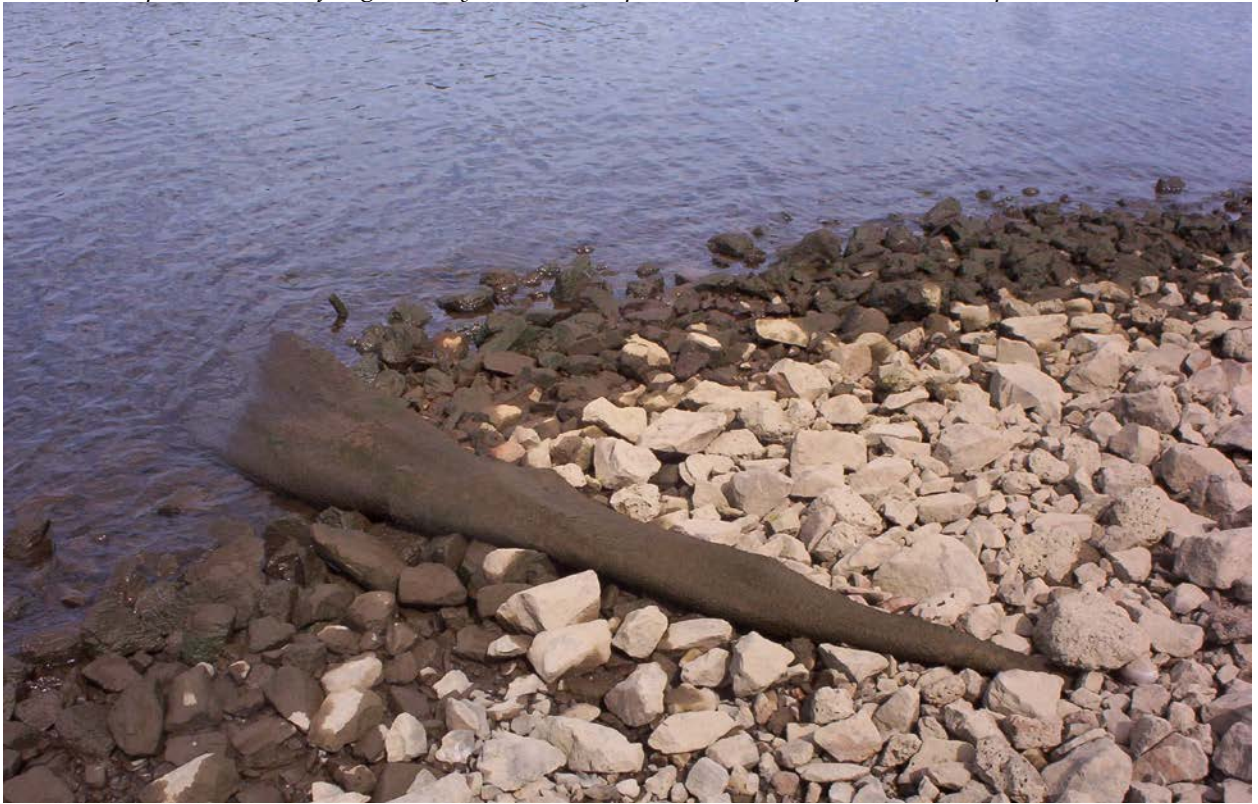
Observations of Erosion/Deposition: No erosion/deposition is evident along the shoreline. Four organoclay mat material segments are exposed and visible. One 20-foot section of organoclay mat is visible at the upriver extent of the cap area (Photo 1). Two segments measuring 4-foot and 2-foot in width are exposed approximately 5-7 feet from the water's edge near the lateral mid-point of the cap area. One 40-foot section of organoclay mat material is exposed near the downriver extent of the cap area.

Photo 1- *Exposed section of organo-clay mat at the upriver extent of the sediment cap (8/20/12):*

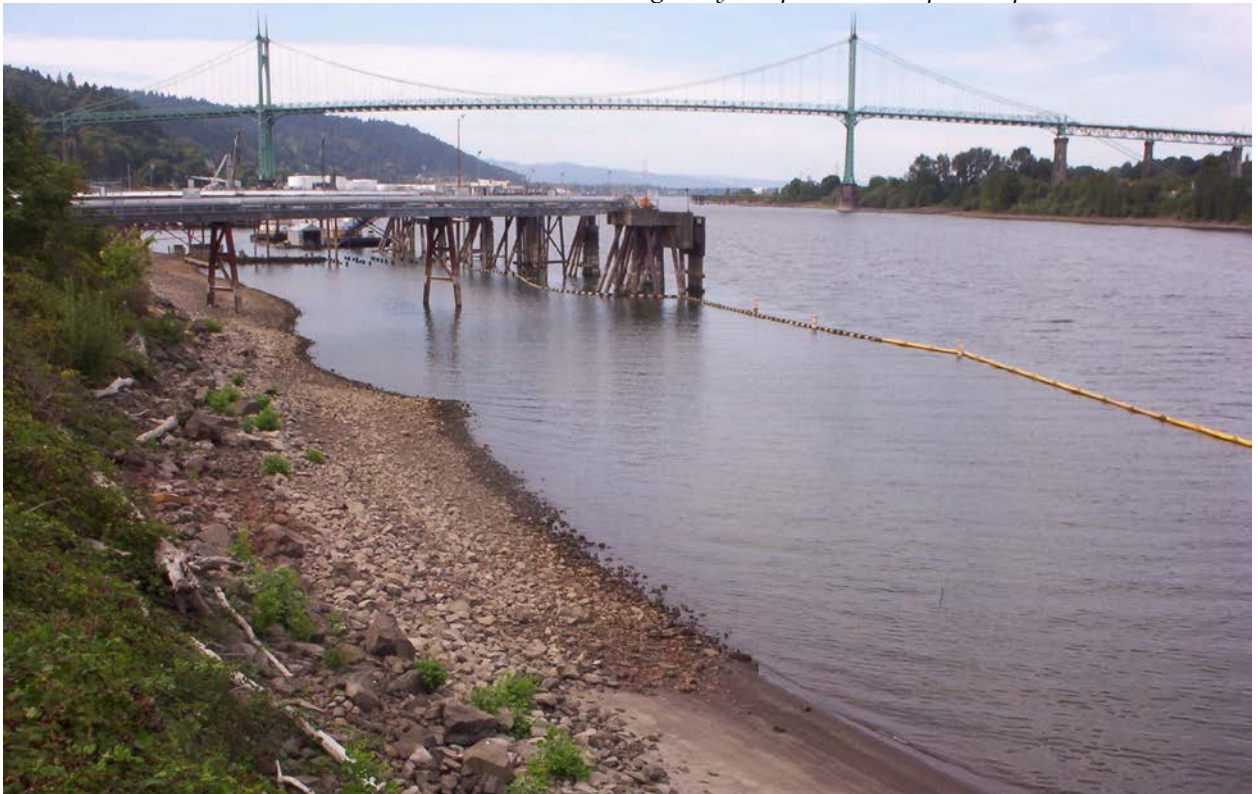
Observations of Long-term Controls (i.e., oil booms, organo-clay mat, etc.) During the observation, the Fuel and Marine Marketing (FAMM) containment boom was in place across the cap area, between the upriver corner of the ship dock and the wooden dolphin (near the upriver extent of the site and near the Siltronic Corporation outfall). Buoys that identify the cap area to mariners are in place as installed. The position of the FAMM oil boom, warning buoys, and a general overview of the site shoreline is shown in Photo 2.

Photo 2 - *FAMM oil boom shown and mariner warning buoys in place across pilot cap area. (8/20/12):*

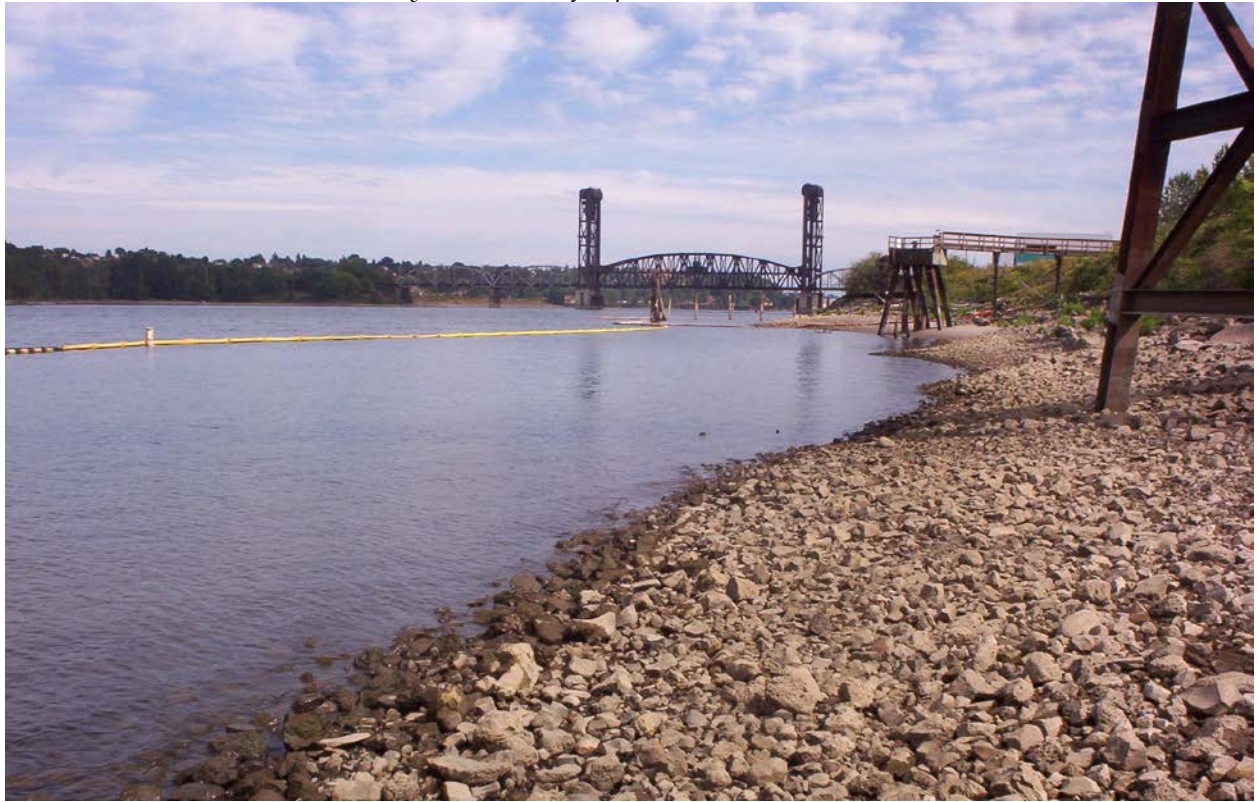
Other Comments: No sheen is evident in or around the cap area. Photo 3 shows the water surface and shoreline immediately downriver of the sediment cap.

Photo 3 — *Conditions immediately downriver of cap area (8/20/12):*
